Drawing  
Masterplan  
Project/Client  
Restoration of Jollies Brook  
Pattie Delamore Partners Limited (PDP)

Project Date  
Feb 2022

Job reference (Drawing number)  
22023-01-01

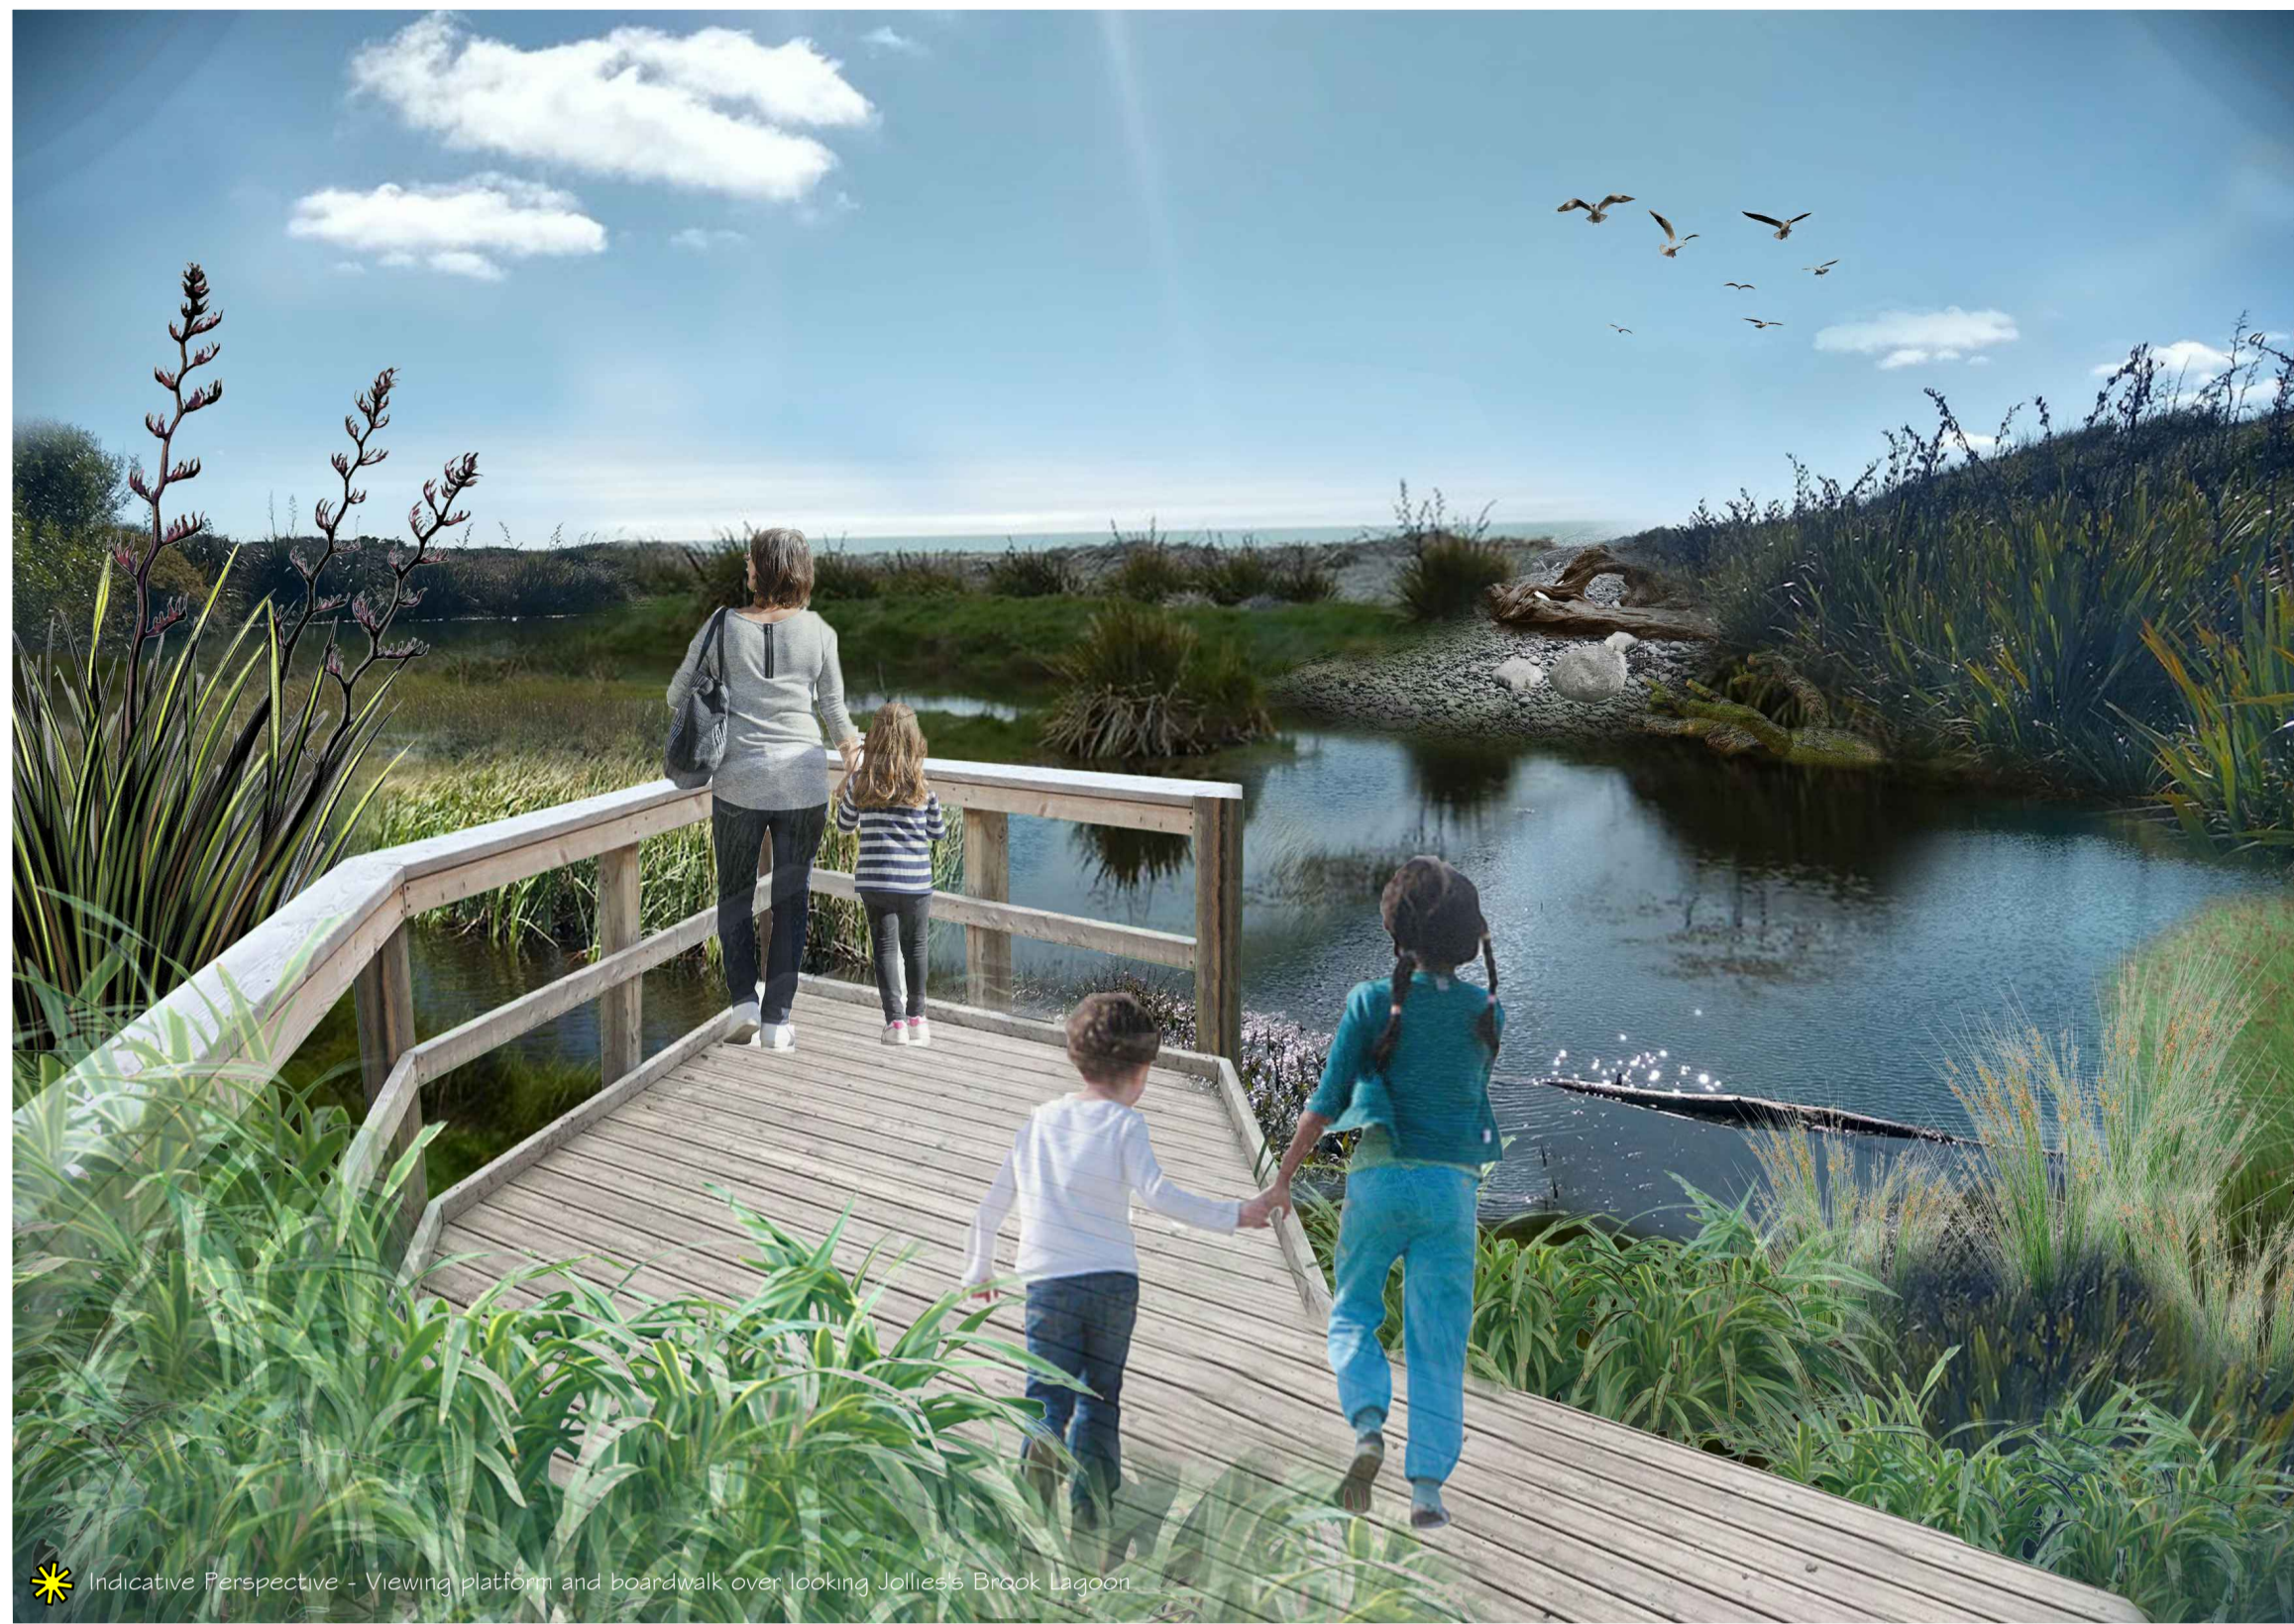
Indicative Perspective - Viewing platform and boardwalk overlooking Jollies Brook Lagoon

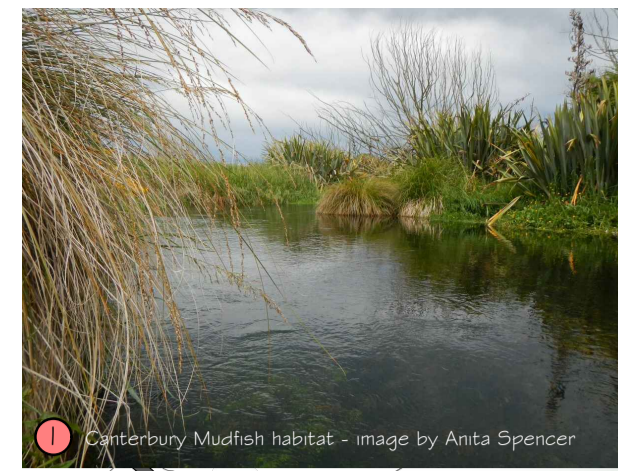
1 Canterbury Mudfish habitat - image by Anita Spence

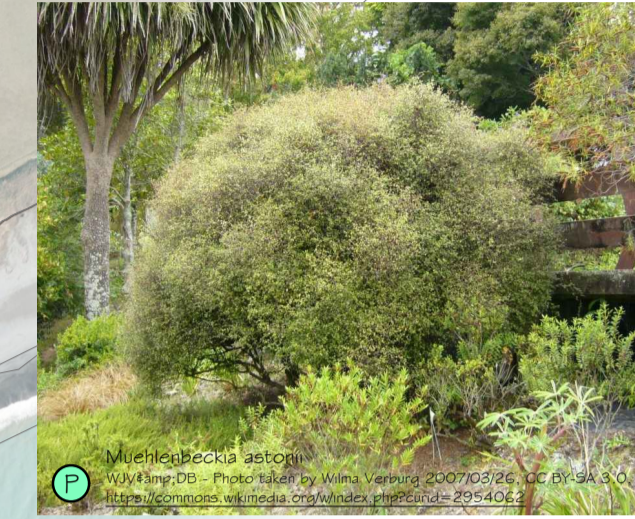
F Threatened native plant species introduced, for example Muehlenbeckia astonii

Threatened native plant species introduced, for example *Muehlenbeckia astonii*

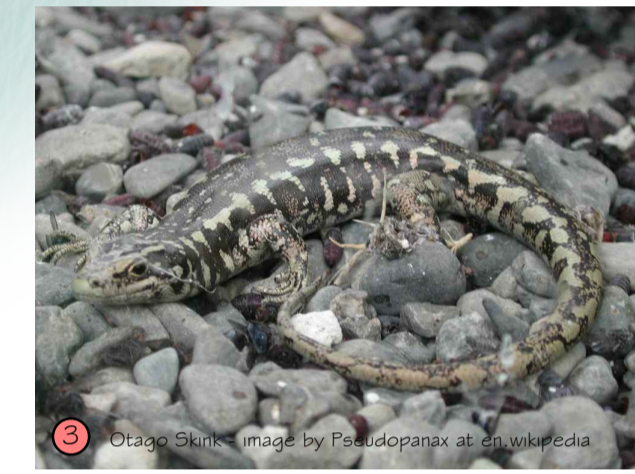
E Lizard Habitat

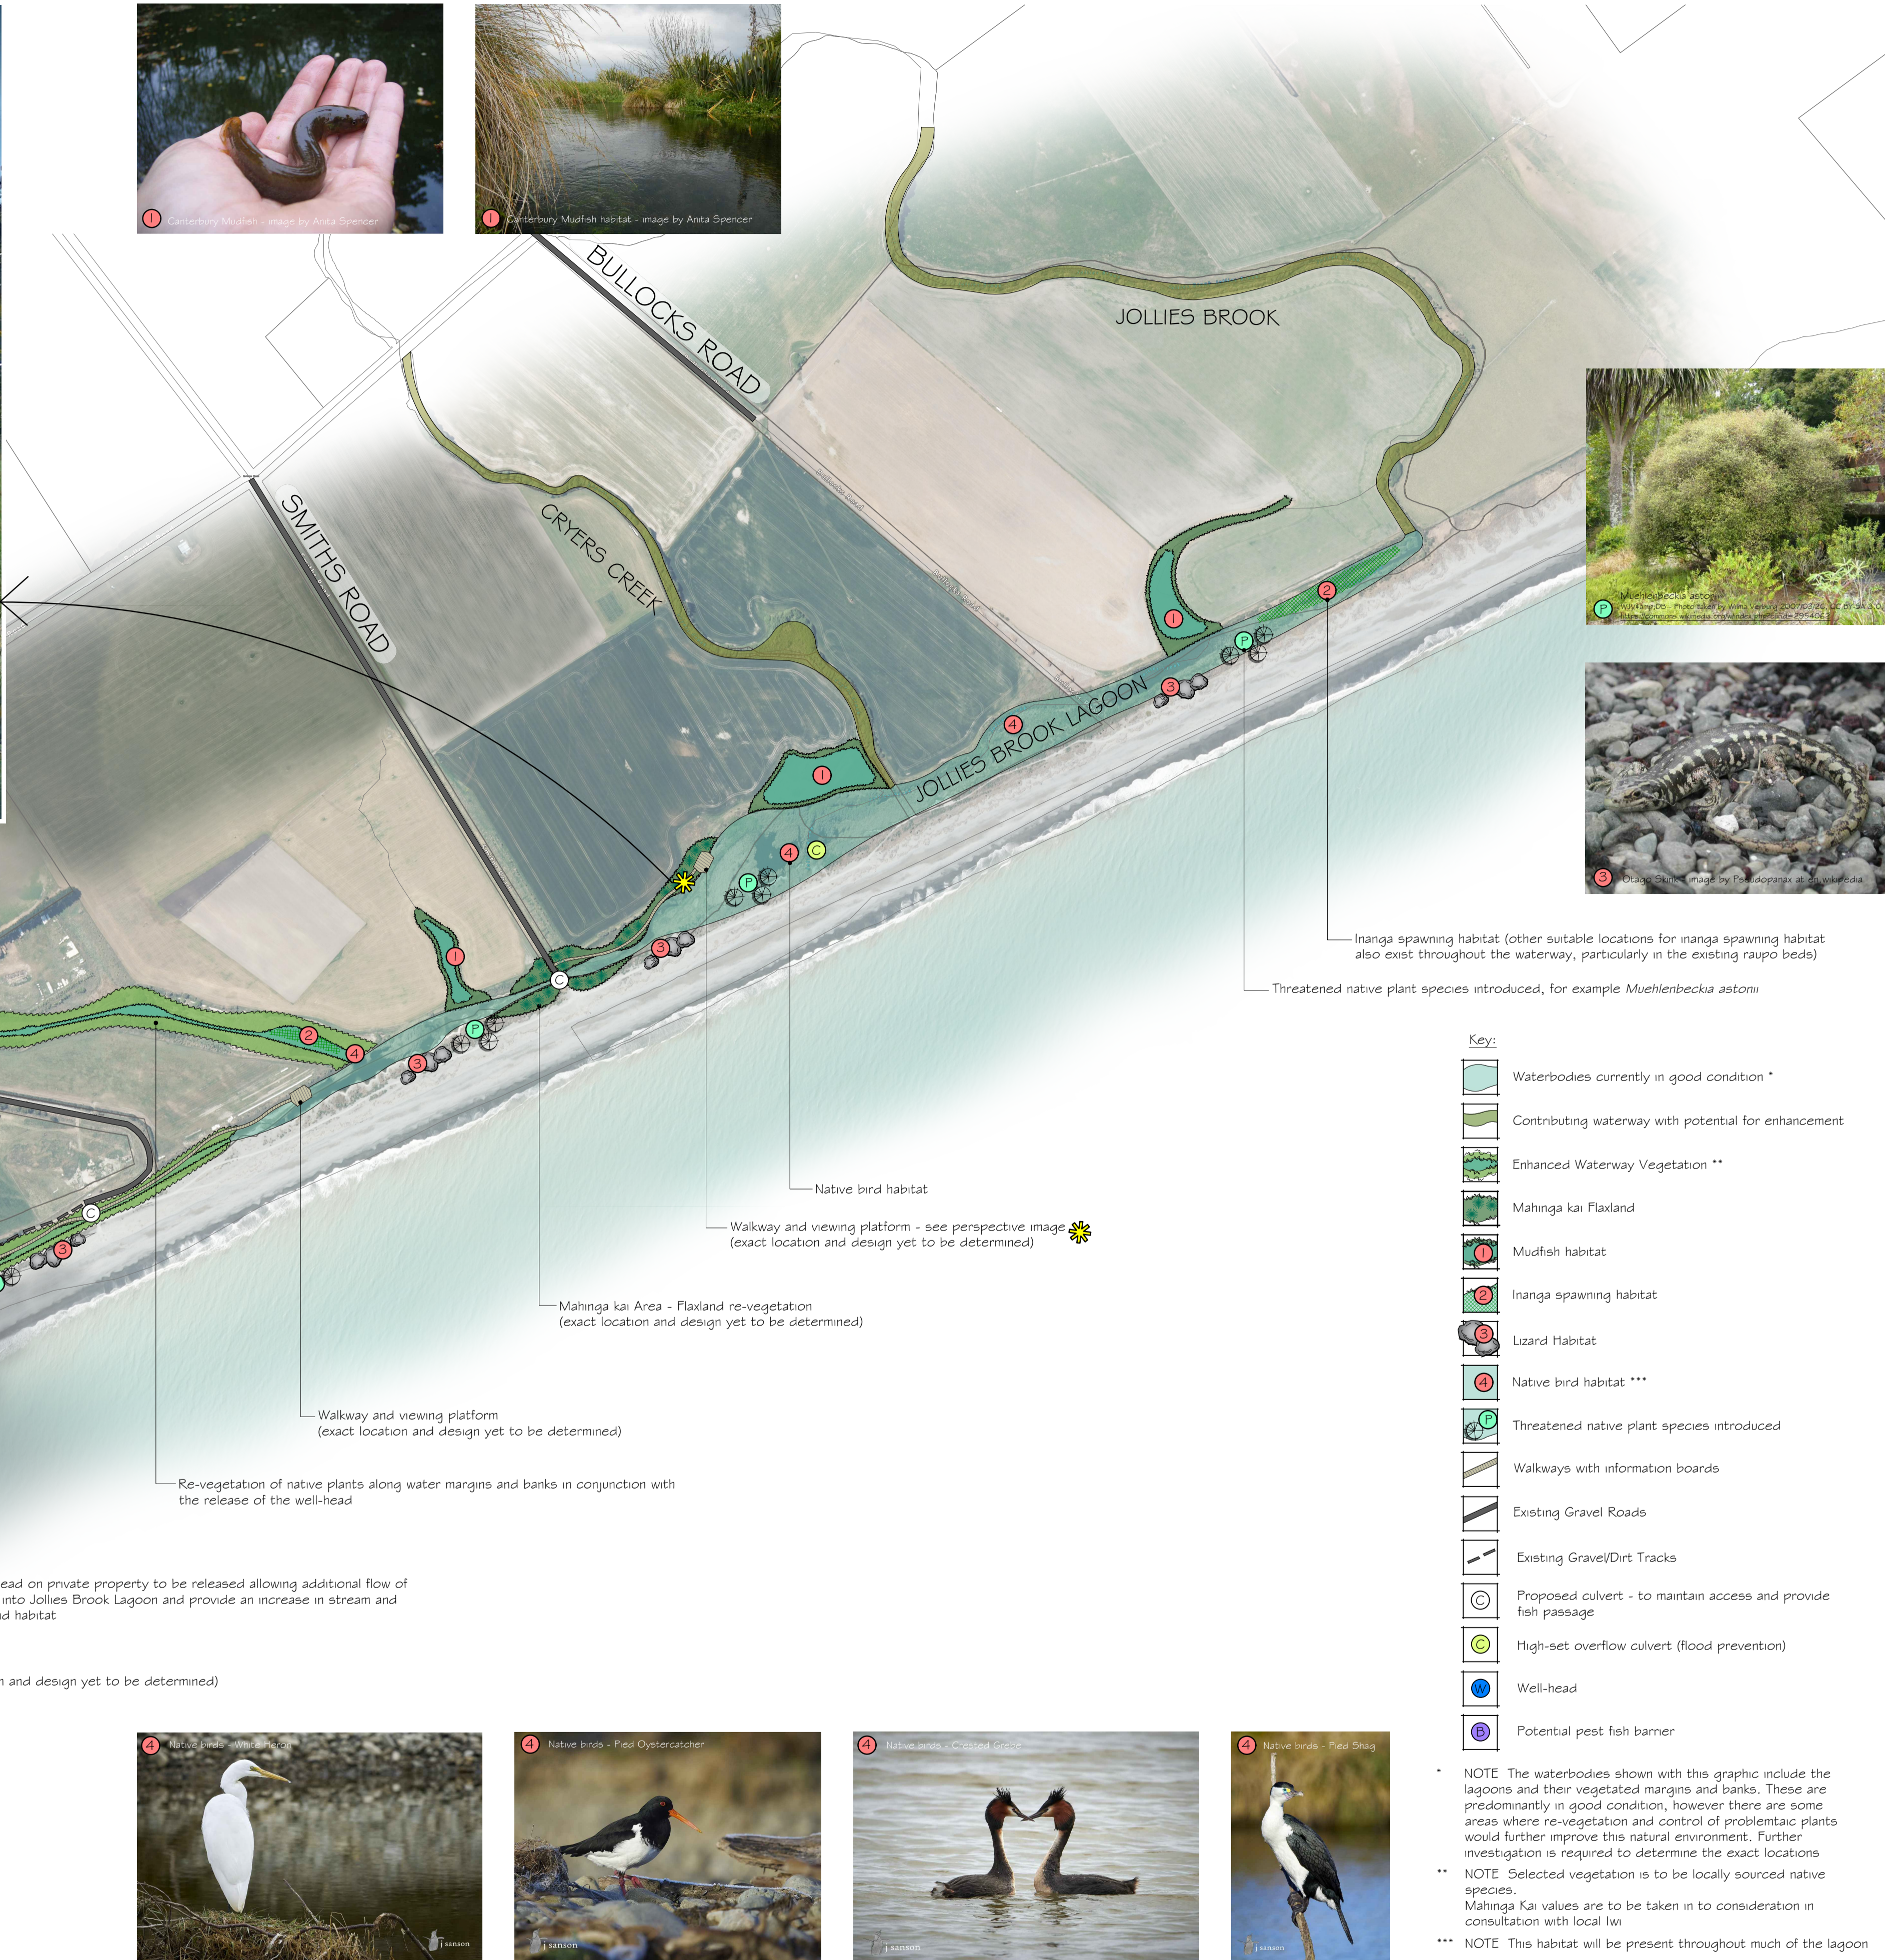
Inanga spawning habitat (other suitable locations for inanga spawning habitat also exist throughout the waterway, particularly in the existing raupo beds)

\* NOTE The waterbodies shown with this graphic include the lagoons and their vegetated margins and banks. These are predominantly in good condition, however there are some areas where re-vegetation and control of problematic plants would further improve this natural environment. Further investigation is required to determine the exact locations

\*\*\* NOTE This habitat will be present throughout much of the lagoon
